**BROOKVILLE LAKE
GREATER MIAMI RIVER BASIN
INDIANA**

**EMBANKMENT CRITERIA AND
PERFORMANCE REPORT**

**PREPARED BY
U.S. ARMY ENGINEER DISTRICT, LOUISVILLE
CORPS OF ENGINEERS**

SEPTEMBER 1982

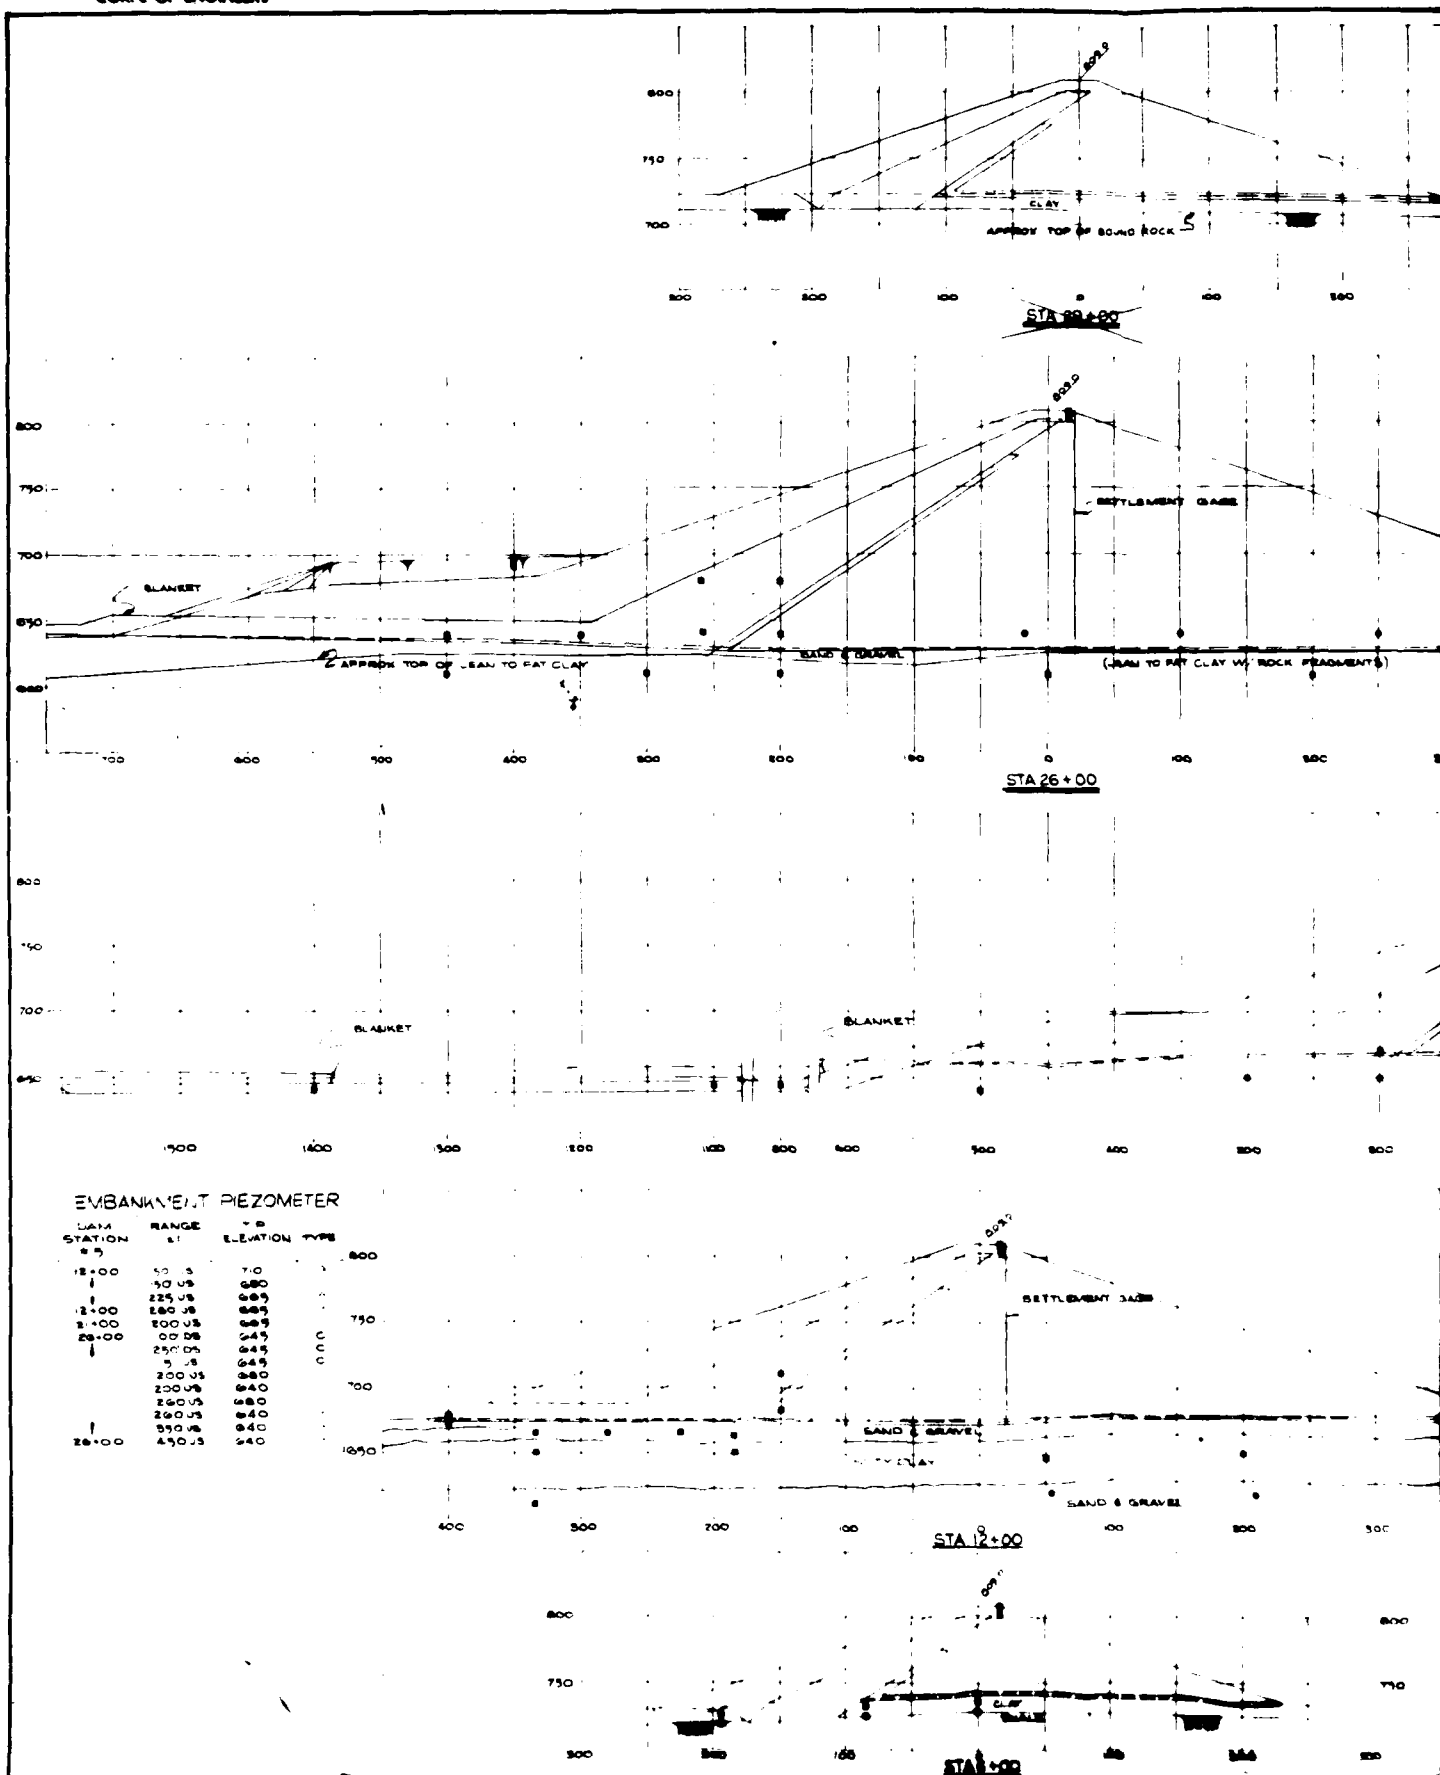
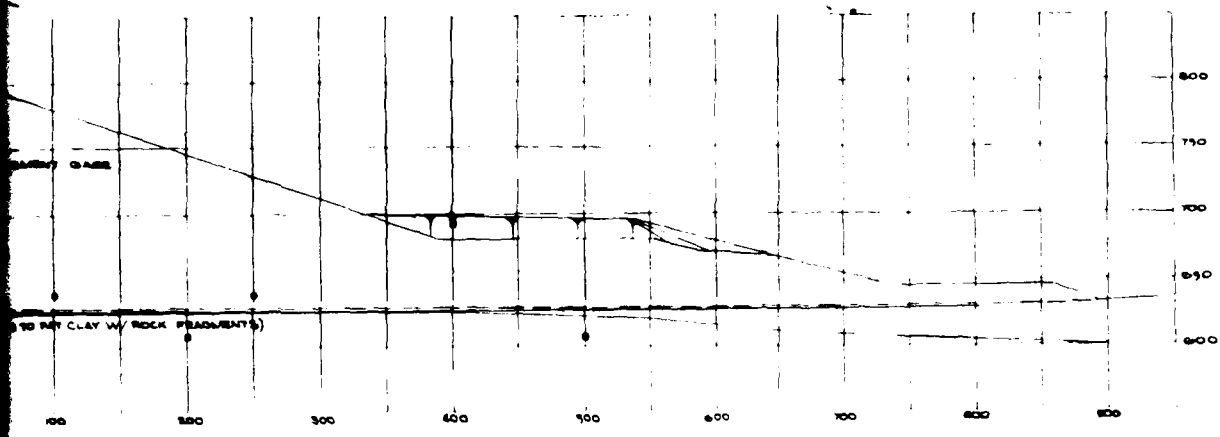
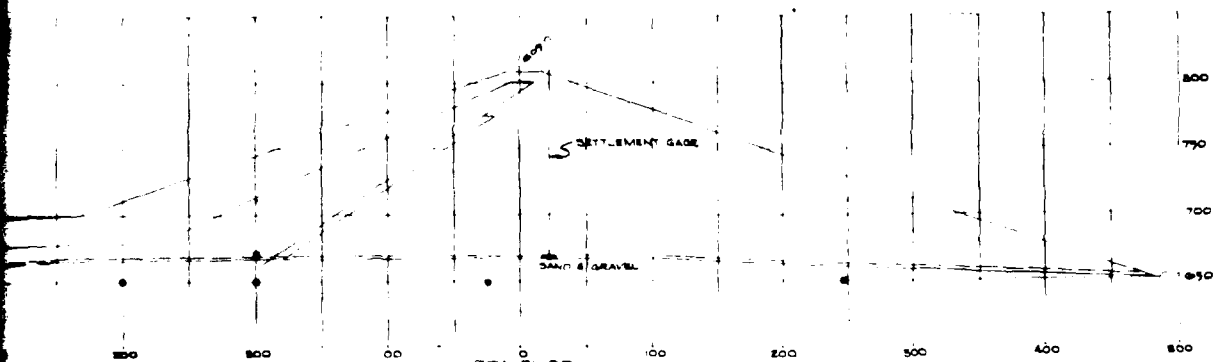
STA 21-00		FOUNDATION PIEZOMETER			
	DAM STATION	RANGE BT	# STRAUTUM LOCATION	TYPE	
800	0+00	0	CLAY		
		75' 00"	1" SHALE CONCRET		
		85' 00"	CLAY		
		95' 00"	1" SHALE CONCRET		
750	0+00	95' 00"	CLAY		
	12+00	95' 00"	1" SHALE CONCRET		
		100' 00"	CLAY		
		105' 00"	LOWER S&G		
		110' 00"	CLAY		
700		115' 00"	LOWER S&G		
		120' 00"	CLAY		
		125' 00"	LOWER S&G		
		130' 00"	CLAY		
	2+00	135' 00"	LOWER S&G		
650	2+00	140' 00"	CLAY		
		145' 00"	S&G		
		150' 00"	S&G		
		155' 00"	S&G		
		160' 00"	S&G		
		165' 00"	BLANKET		
		170' 00"	BLANKET		
		175' 00"	S&G		
		180' 00"	S&G		
	2+00	185' 00"	S&G		
	26+00	190' 00"	CLAY		
		195' 00"	CLAY		
		200' 00"	CLAY		
		205' 00"	CLAY		
		210' 00"	CLAY

APPROVAL	DATE	DESCRIPTION	BY
U S ARMY ENGINEER DISTRICT LOUISVILLE CORPS OF ENGINEERS LOUISVILLE DISTRICT			
DESIGNED		OHIO RIVER BASIN	
DRAWN	TRACED	BROOKVILLE RESERVOIR	
D.P.H.	G.B.B.	EAST FORK WHITEWATER RIVER, INDIANA	
CHECKED		DAM	
BY		PIEZOMETER INSTALLATION	
APPROVED			
APPROVAL SIGN		ISSUES	DATE
BY			
FOR CHIEF ENGINEER OF DISTRICT	CHIEF ENGINEER OF DISTRICT	APPROVED	
APPROVED	SCALE		
PLATE NO. 20		DRAWING NO. : EFW-2-12379

(1) General. Most of the closed system piezometers initially installed in the dam have become inoperative and, where possible, were recently replaced by Casagrande type piezometers. The following table summarizes the status of the closed system piezometers as of 1 July 1979.

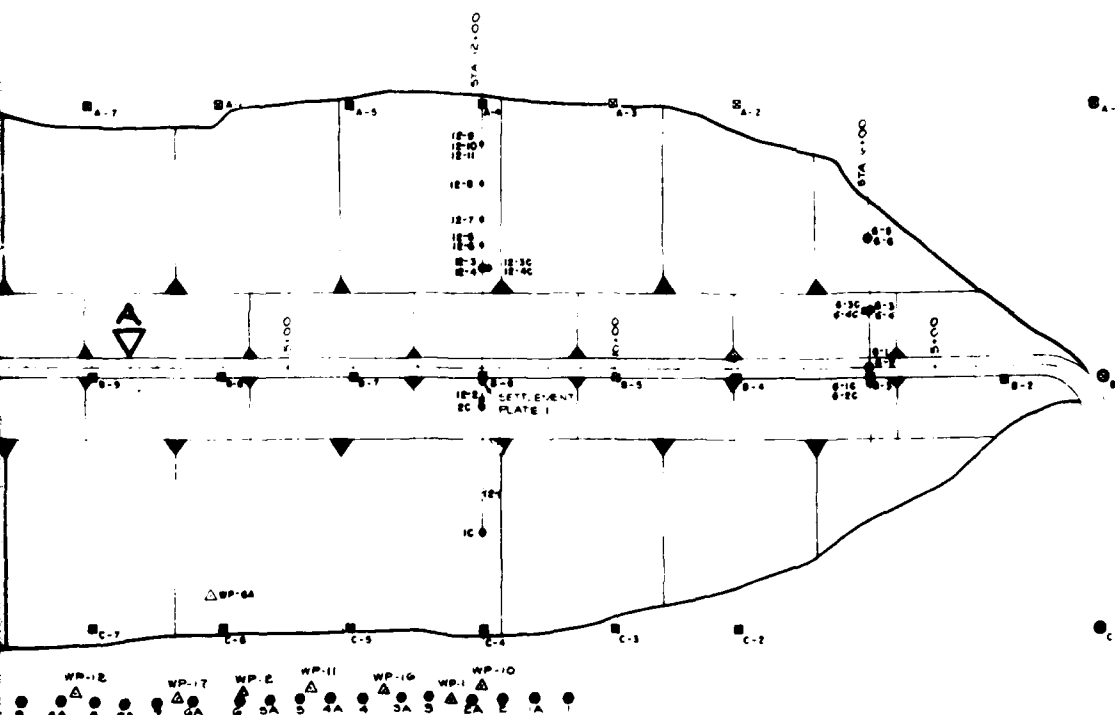
- GAS ACTUATED PIEZOMETER
- CALAGRANDE TYPE PIEZOMETERS
- MOVEMENT MONUMENTS
- REFERENCE MONUMENTS
- △ WELL CONT TYPE 172 METERS
- SETTLEMENT PLATES
- RELIEF WELLS
- OPERATIVE GAS ACTUATED PIEZOMETER

REVISION		DATE	DESCRIPTION	BY
U. S. ARMY ENGINEER DISTRICT, LOUISVILLE				
CORPS OF ENGINEERS				
LOUISVILLE DISTRICT				
DRAWING		DMD RIVER BASIN		
SCALE		BROOKVILLE RESERVOIR		
EAST FORK WHITEWATER RIVER, INDIANA		DAM		
INSTRUMENTATION PLAN		DRAWING NUMBER

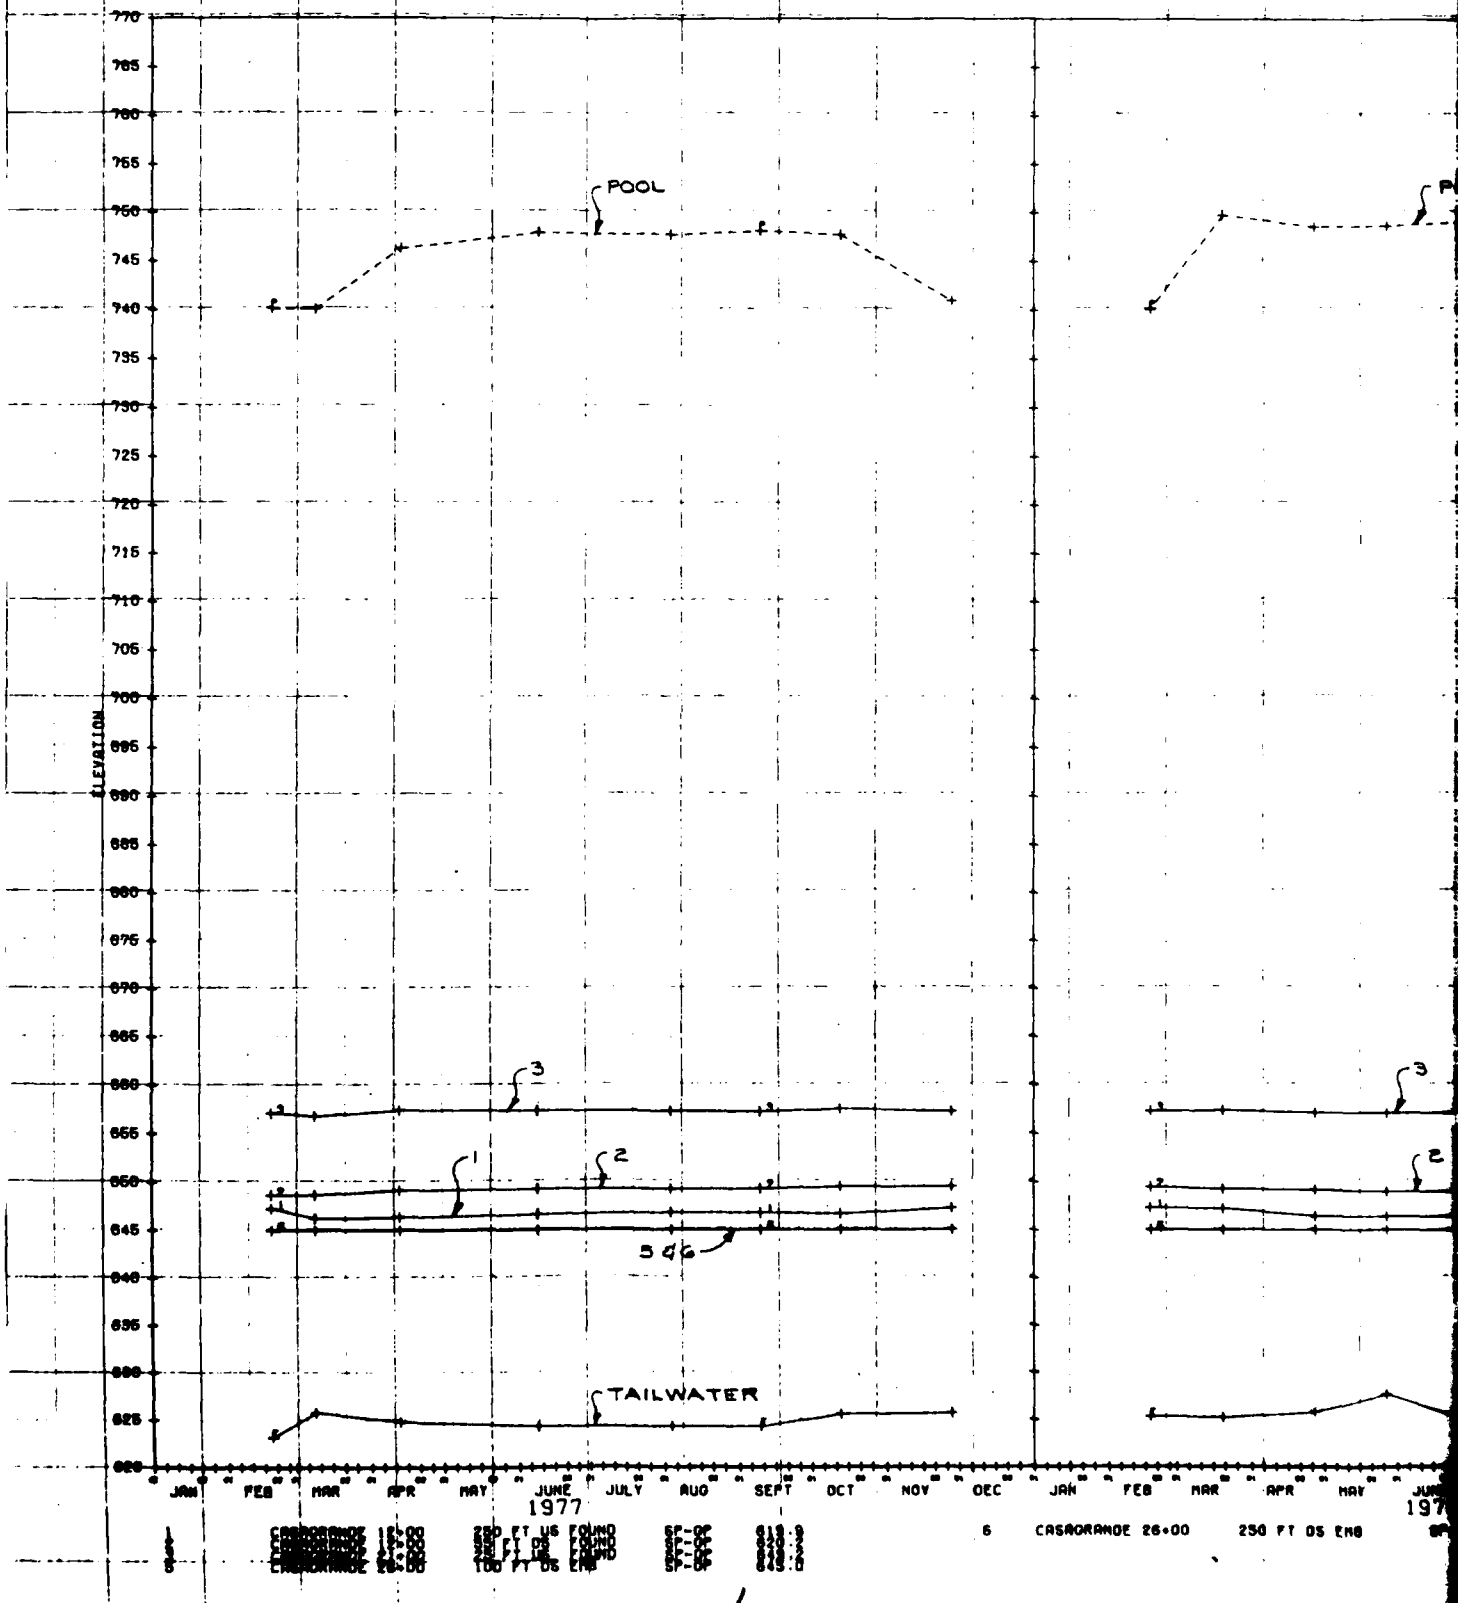
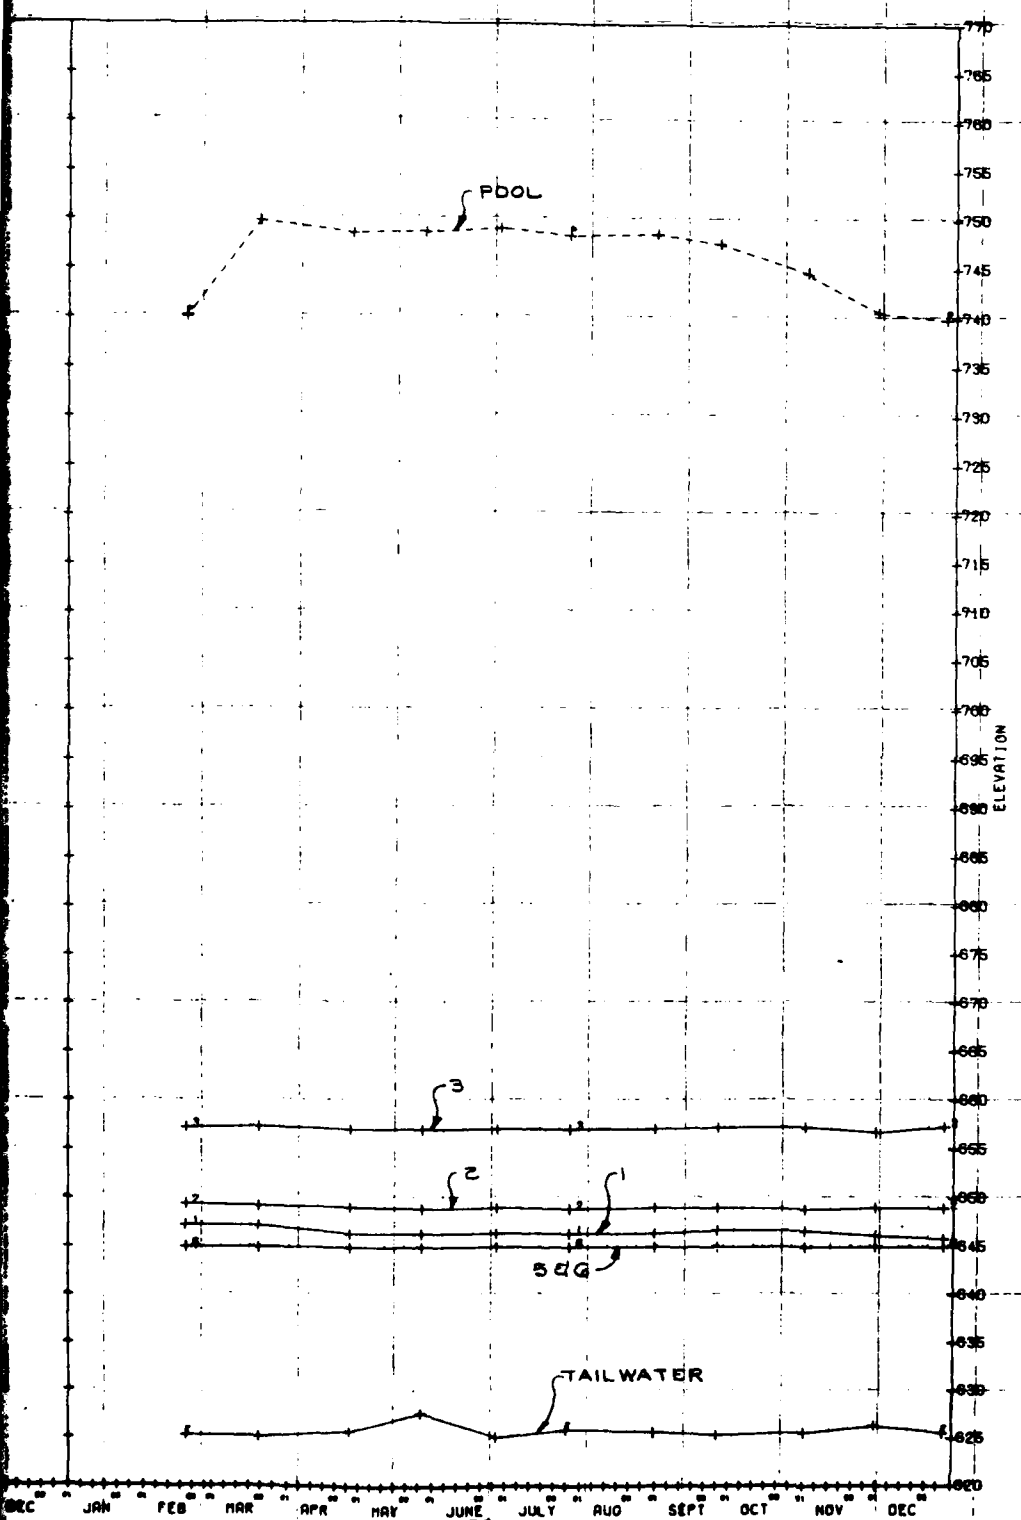
BROOKVILLE CASAGRANDE PIEZOMETERS

CASAGRANDE 18-00
 CASAGRANDE 26-00
 250 FT US FOUND
 100 FT DS END

6 CASAGRANDE 26-00 250 FT DS END

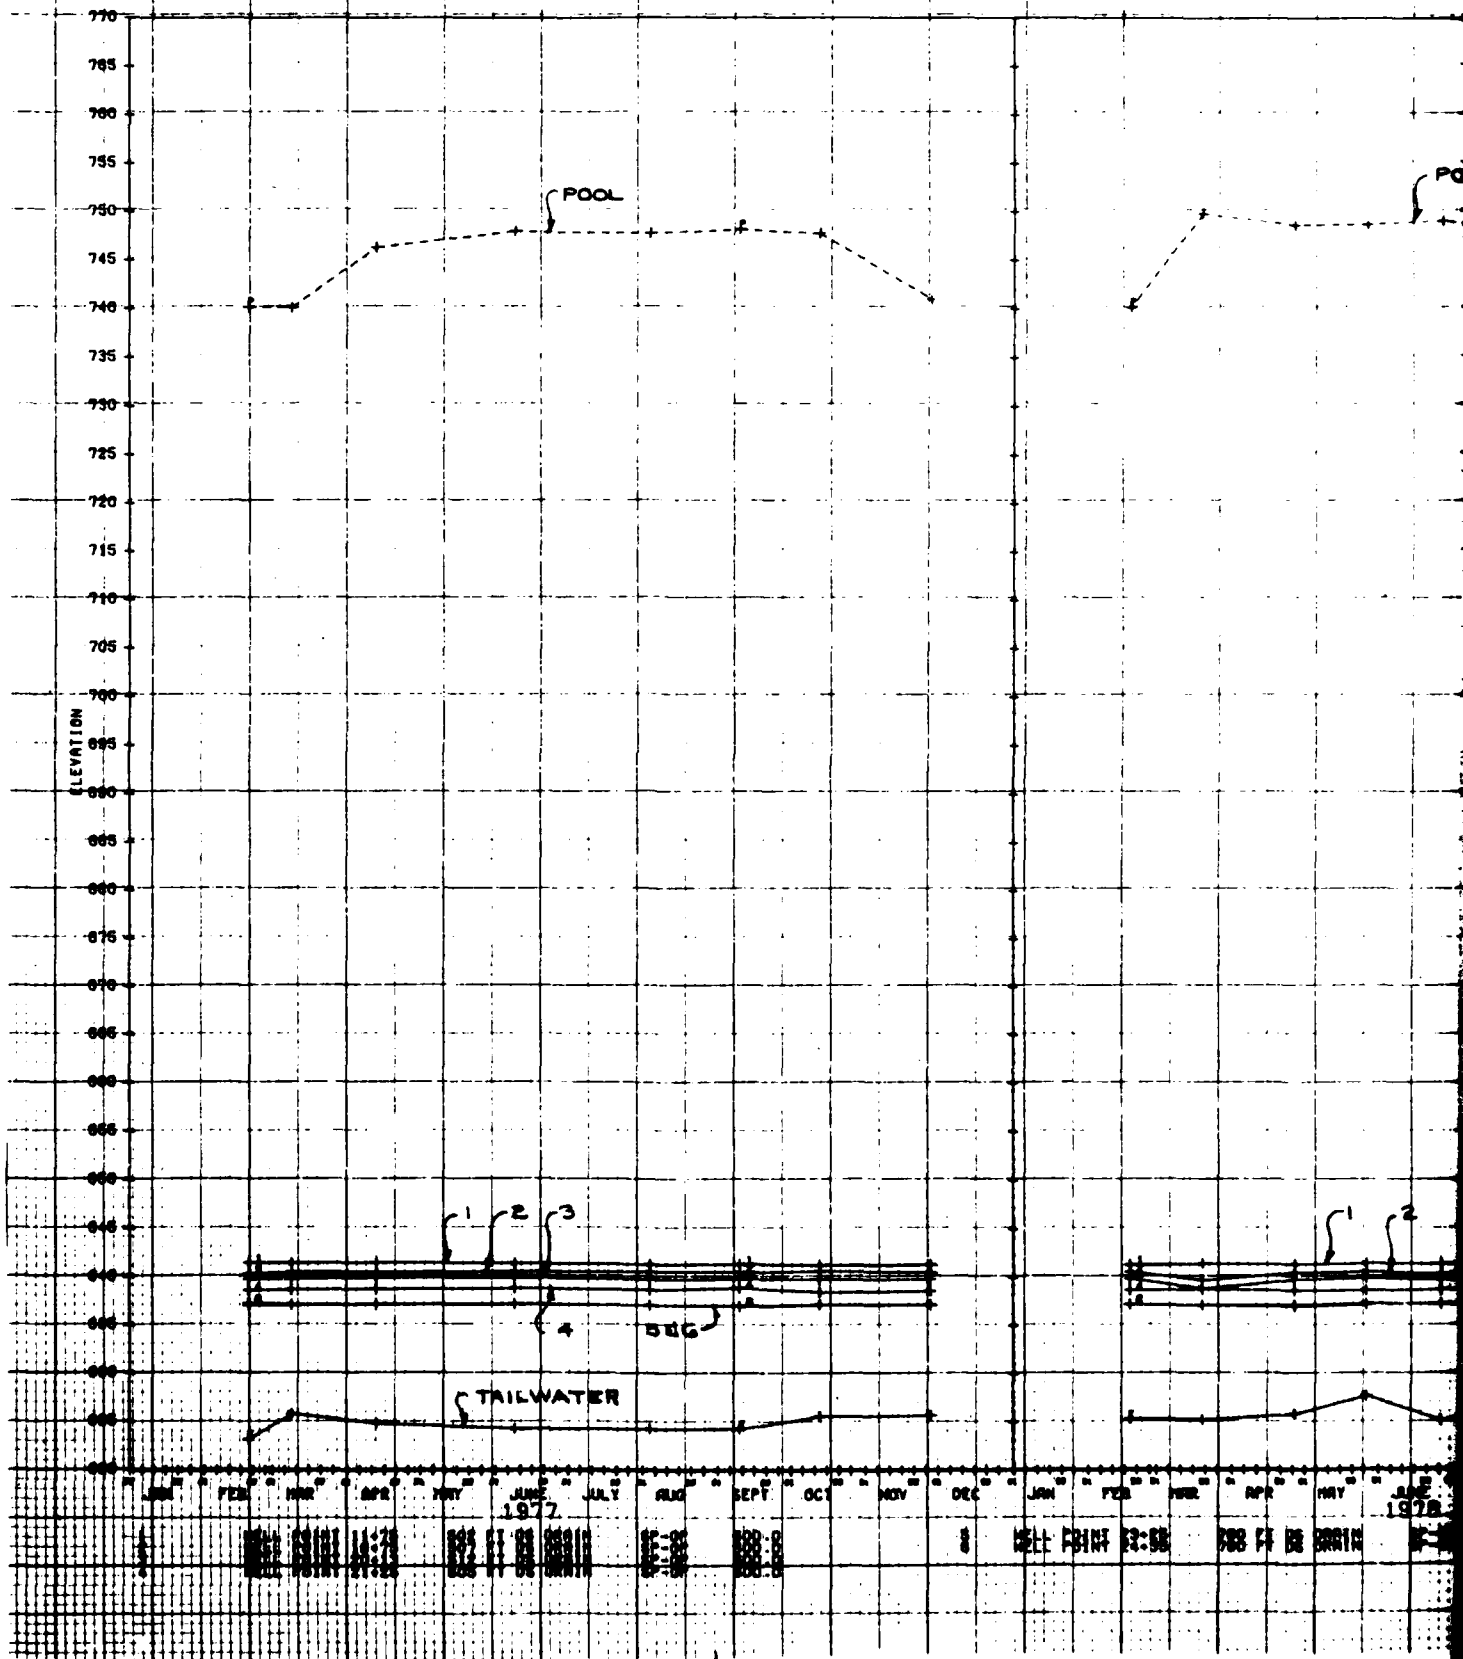
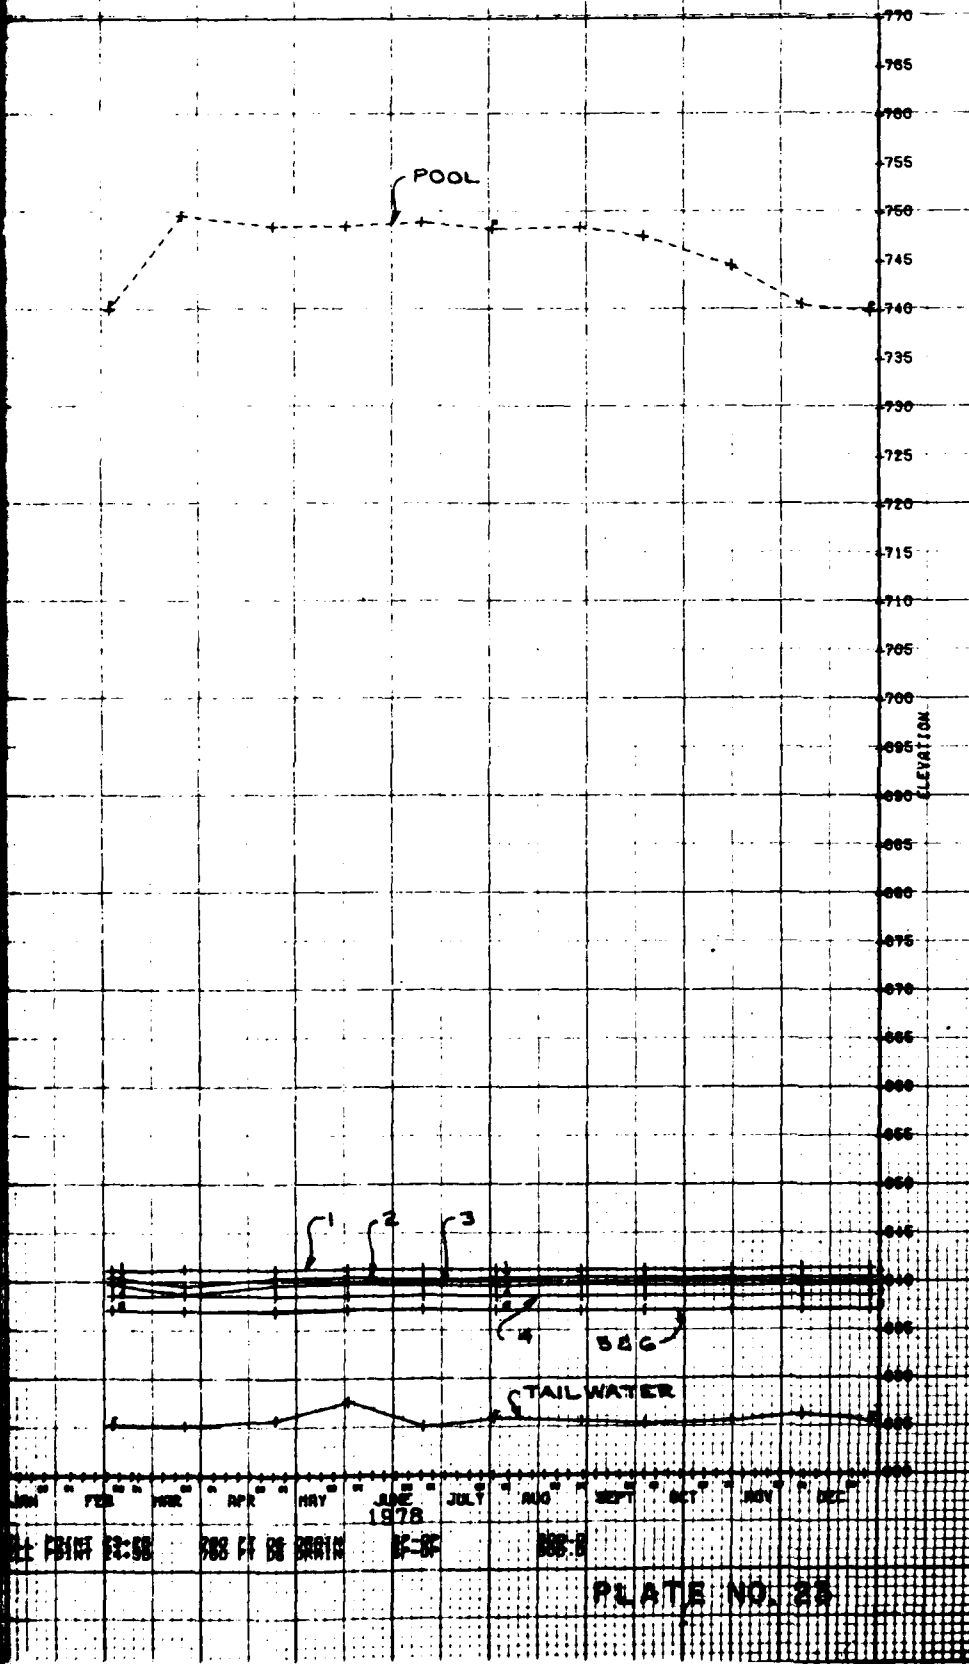
BROOKVILLE WELLPPOINT TOE DRAIN PIEZOMETERS

TOE DRAIN PIEZOMETERS

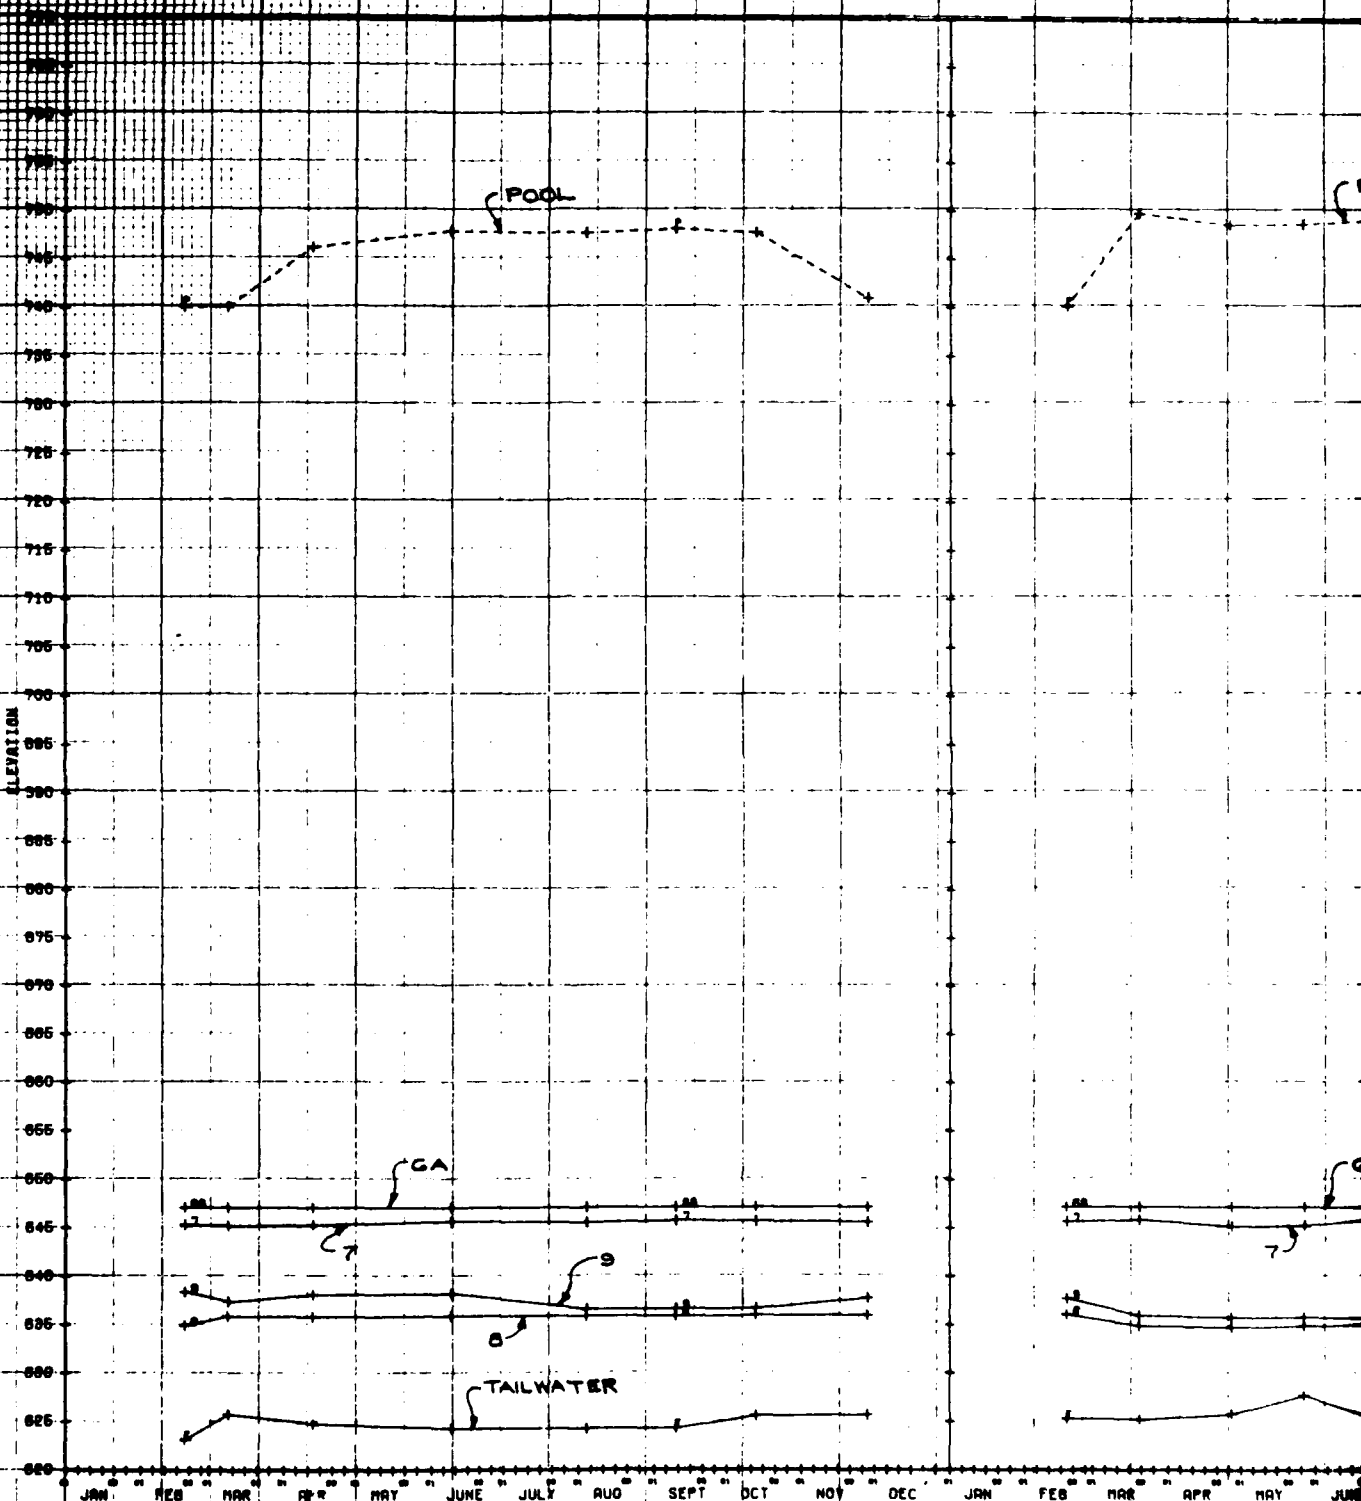
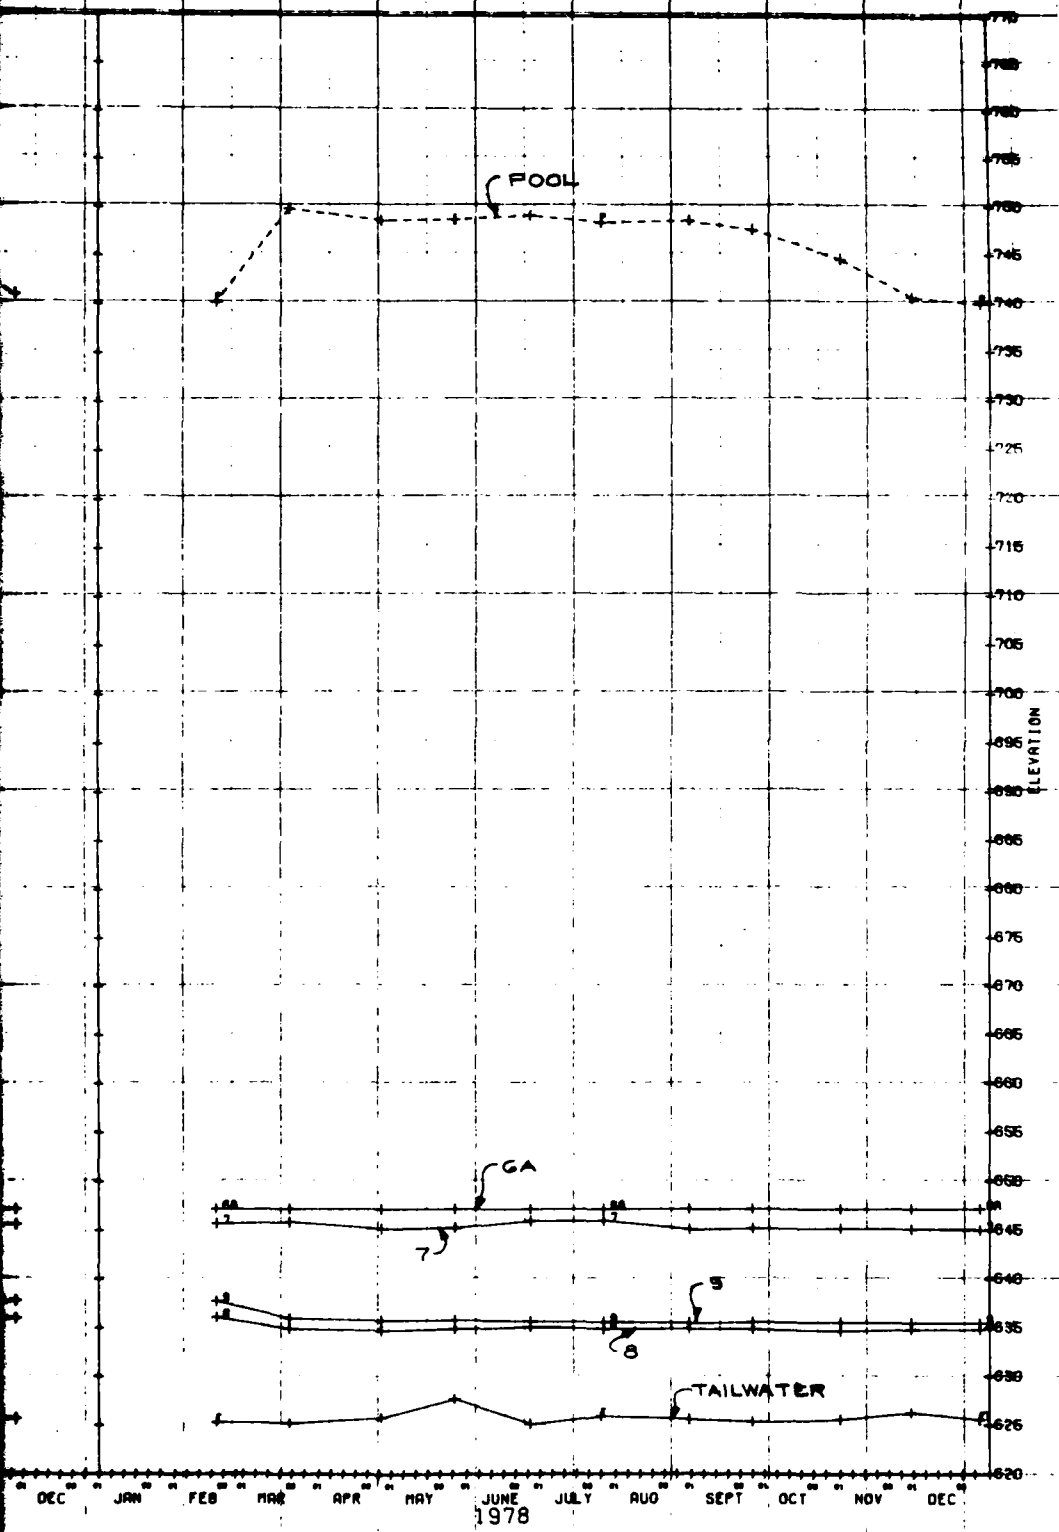
BROOKVILLE WELLPPOINT D.S. FOUNDATION PIEZOMETERS

WELL POINT 18-25 380 FT DE ORIGIN 647-3
WELL POINT 22-25 1200 FT DE ORIGIN 641-3

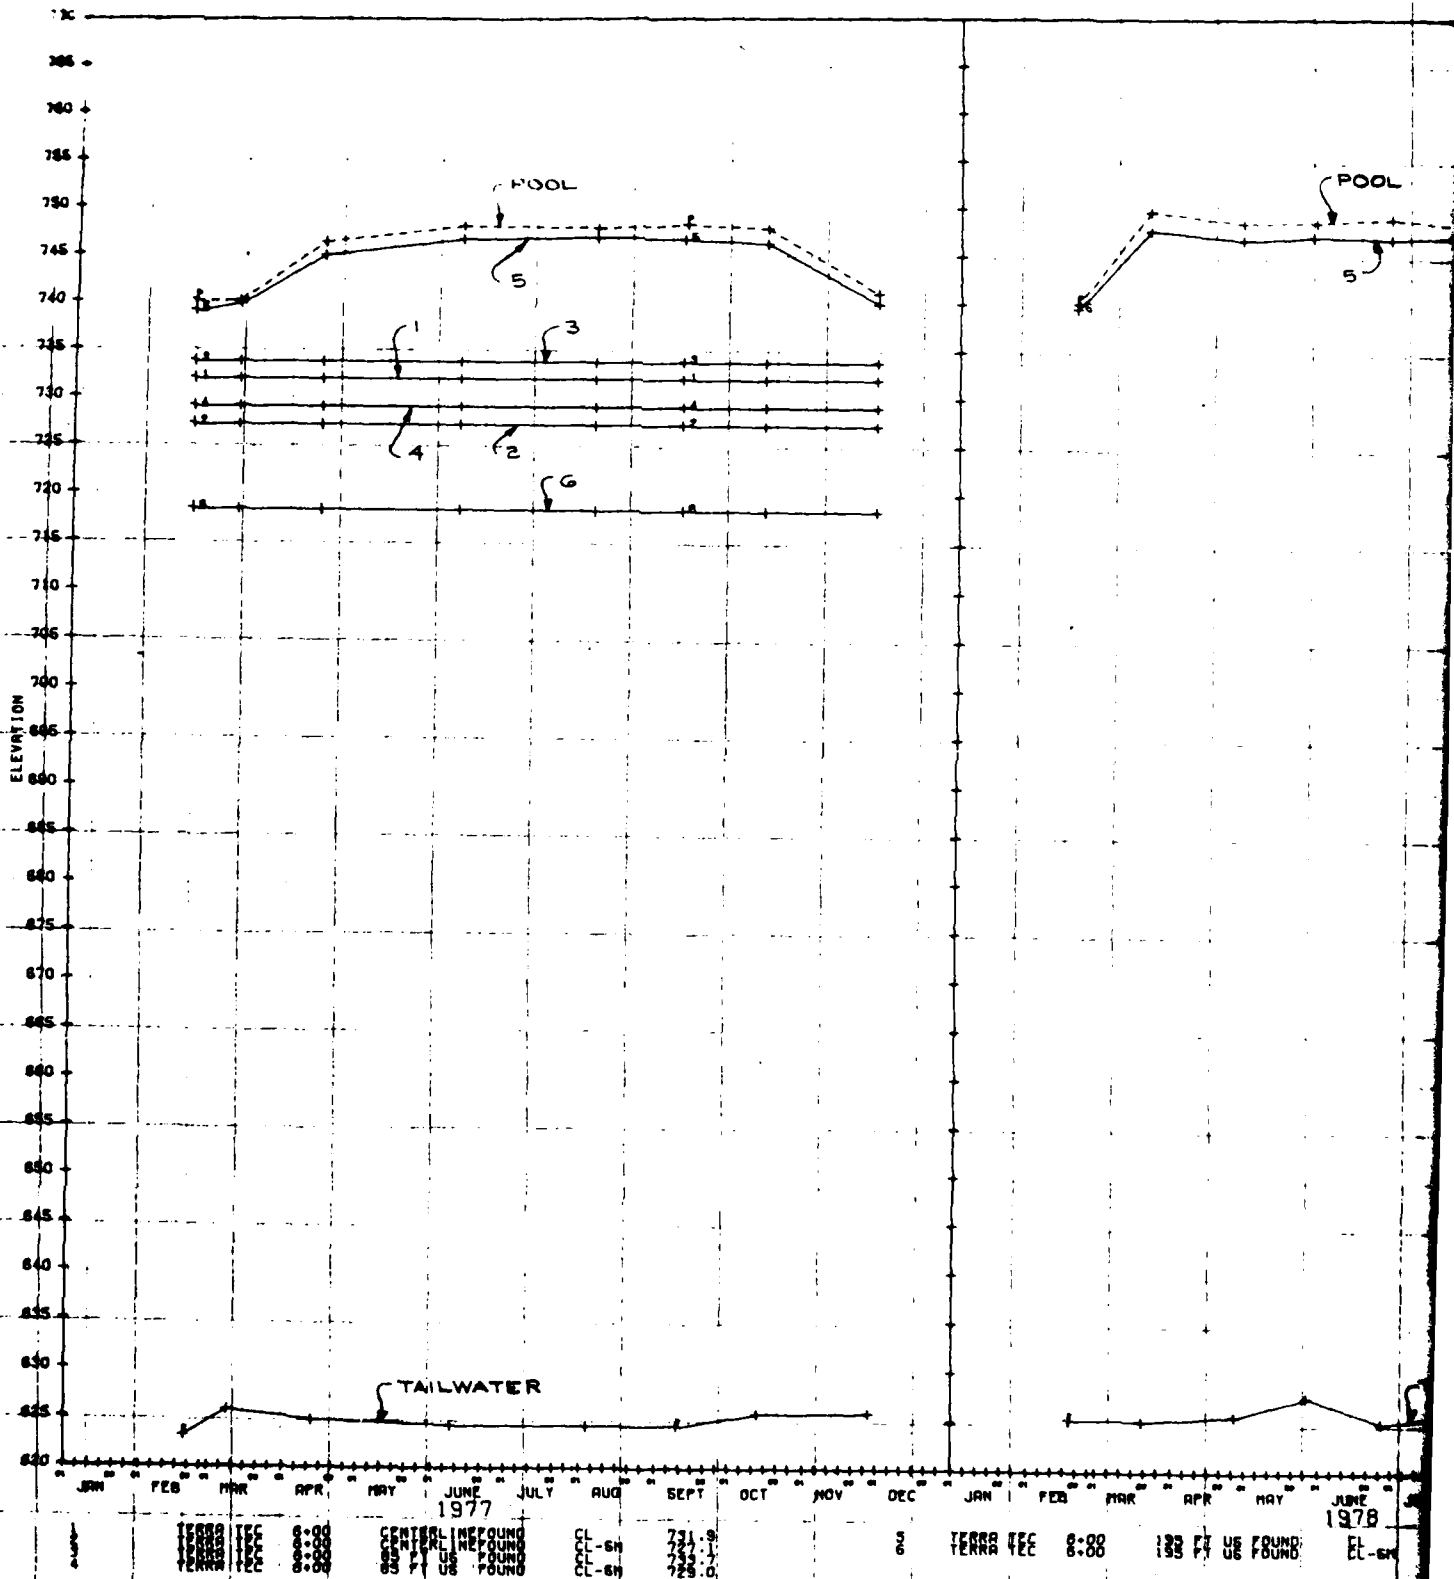
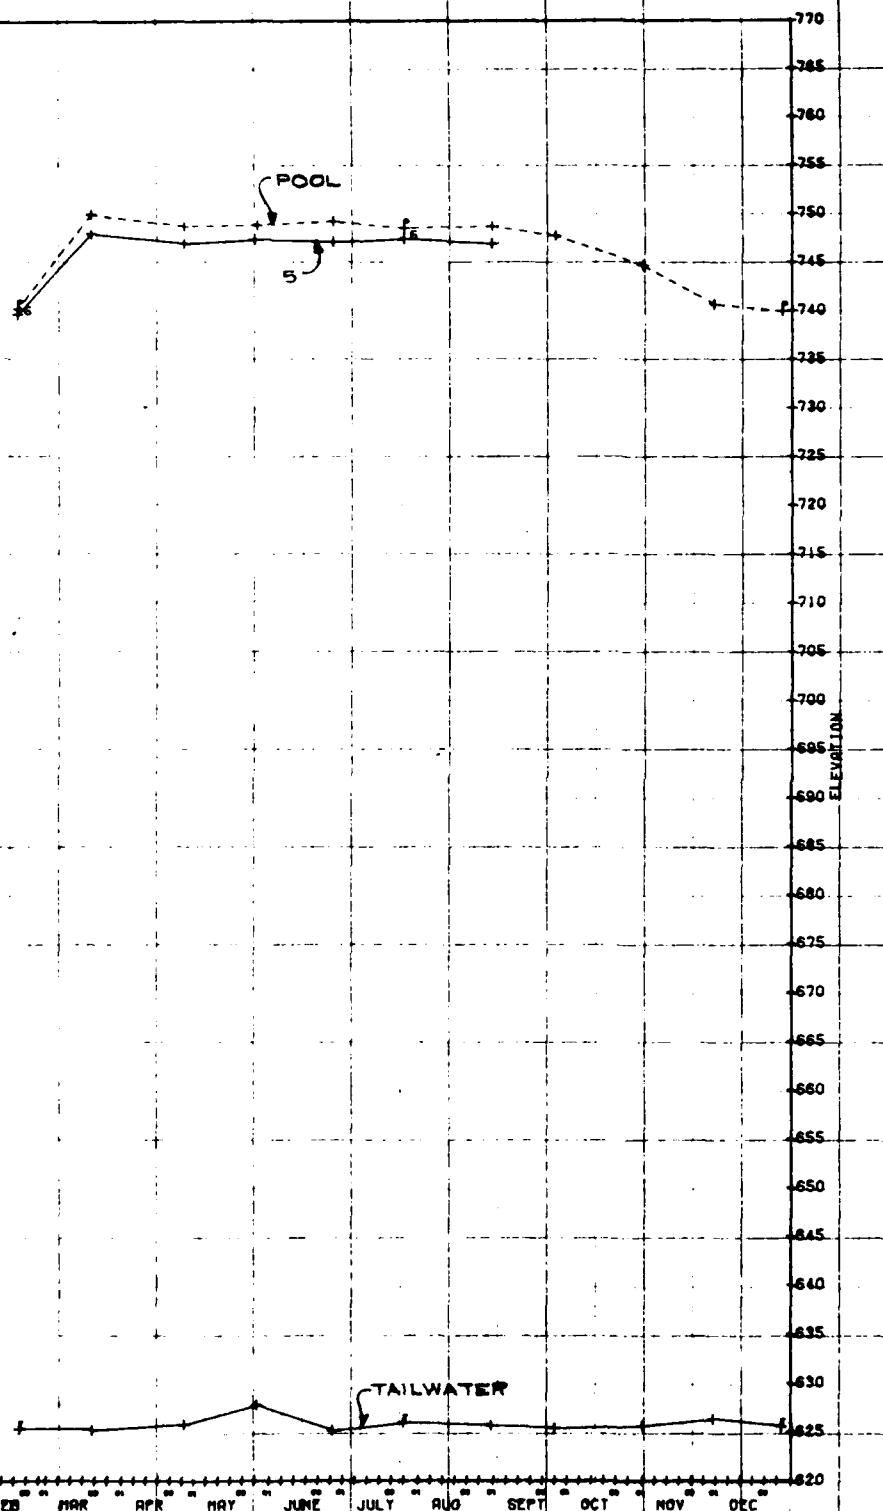
BROOKVILLE U.S. FOUND PIEZ. STA 6+00

TERRA TEC	8-00	CENTRAL LINE FOUND	CL-6H	721.9		TERRA TEC	8-00	133 FT US FOUND	EL-6H
TERRA TEC	8-00	85 FT US FOUND	CL-6H	727.7					
TERRA TEC	8-00		CL-6H	729.0

(a) Station 6+00--The replacement piezometers are the only operative piezometers at this station. These piezometers were recently set and have not stabilized yet.
